N558WH Preliminary Occurrence Report

Release date: 12th June 2024

Location	Accident number
Lynden Pindling Int'l Airport (MYNN), Nassau, Bahamas	OCC-2024/0027
Occurrence Date & Time	Registration
2 nd June 2024 11:56 am (1556 UTC)	N558WH
Aircraft	Serial Number
Beechcraft Baron 58	TH-1356
Flight Conducted Under	
Instrument Flight Rules

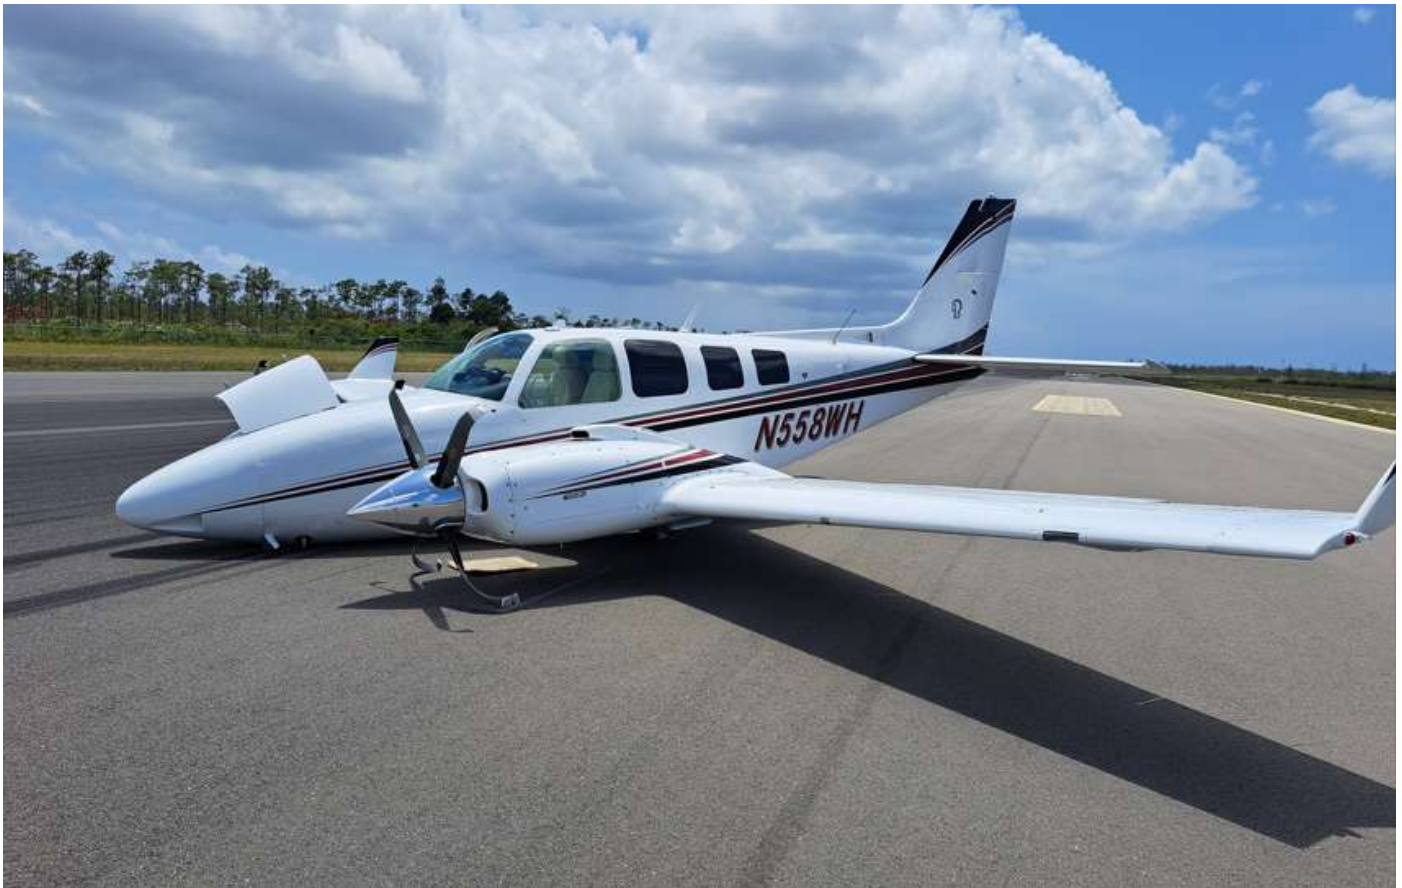
Fig.1: N558WH on runway 10 at MYNN

The aircraft received damages to both propellers, underside of fuselage and landing gear doors. There were no injuries reported to the occupants of the aircraft.

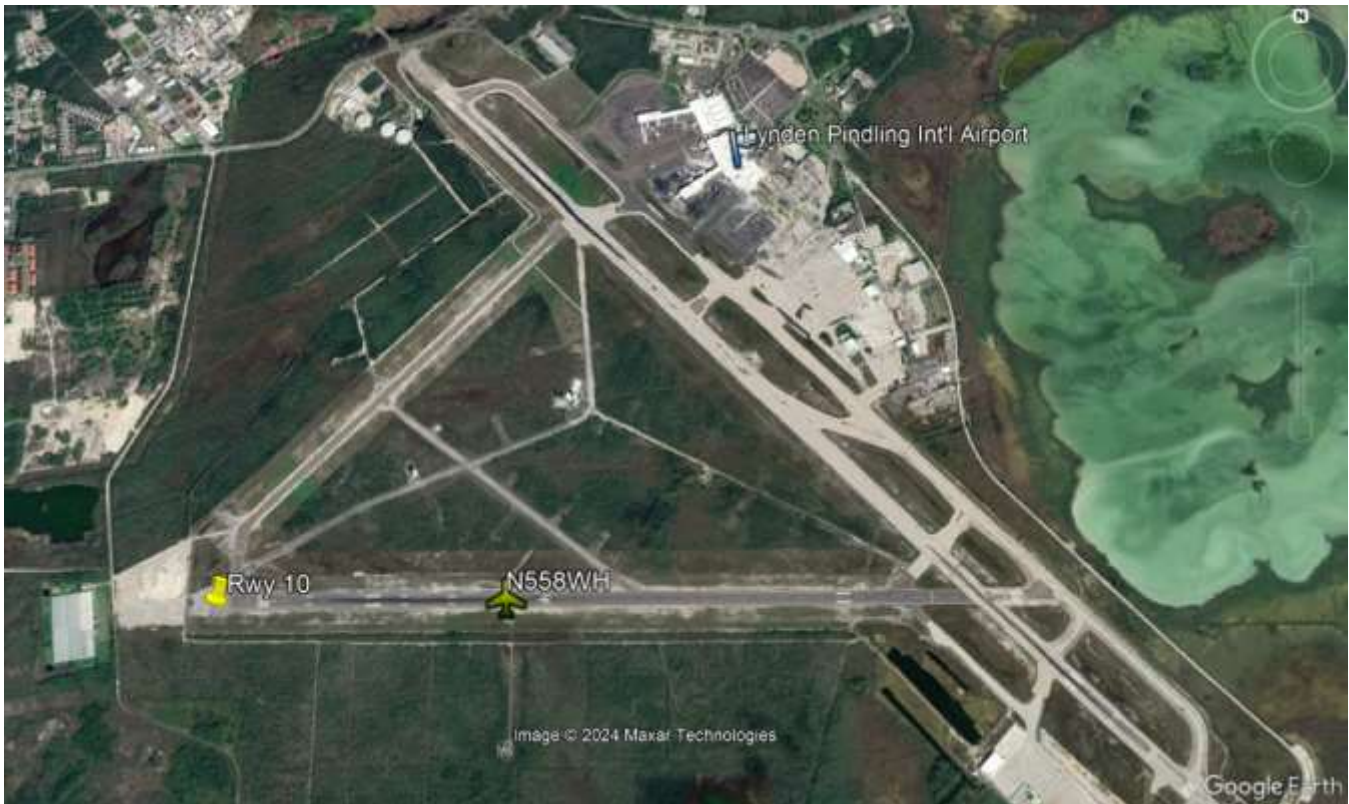
The aircraft came to rest at coordinates 25° 2'10.00"N and 77°28'23.00"W, a distance of approximately 2,592 feet from the beginning of the threshold of runway 10.

Fig.2: Position of N558WH on runway 10 at MYNN

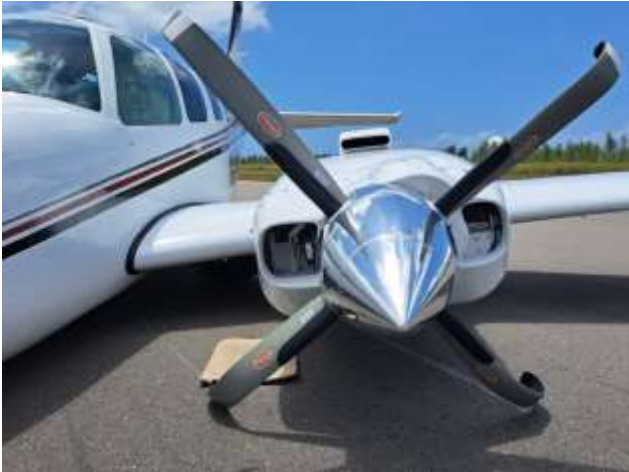
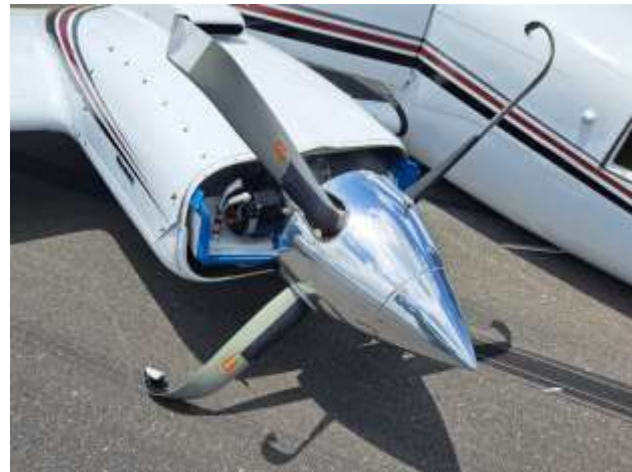
Both propellers,
underside of fuselage,
landing gear doors

Fig.3: Left and right engines after landing at MYNN
