Aviation Short Investigation Final Report

Collision with Obstacle during Takeoff
(CTOL)

Cessna 402C – C6-JTJ

AAIA Aviation Occurrence Investigation
Report # OCC-2024/0012

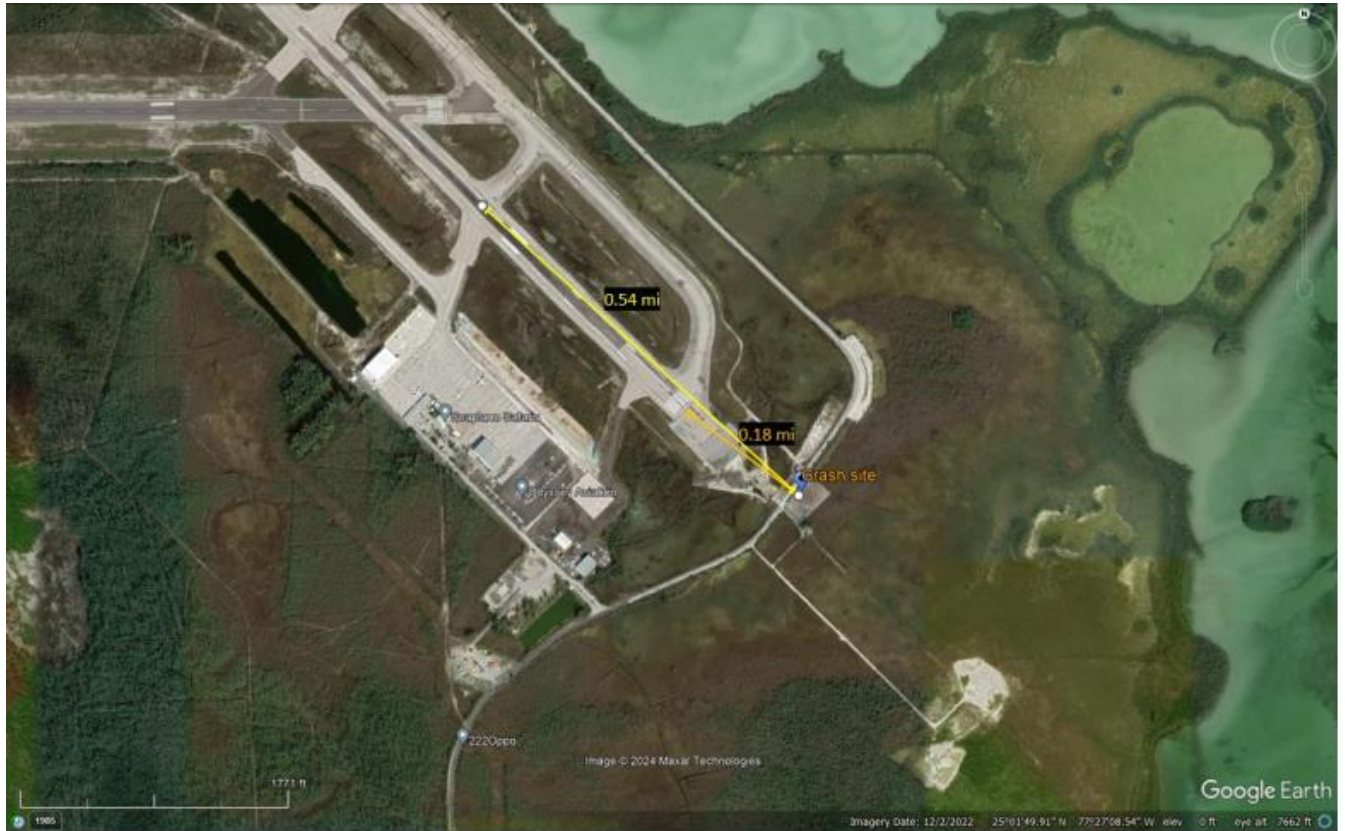
The aircraft impacted the inner layer of perimeter fencing, hitting the surface and travelling for some 57 feet on a heading of approximately 123° before impacting the second outer layer of perimeter fencing. The aircraft’s trajectory continued in that general direction travelling for an additional 216 feet, sliding across Coral Harbour Road before coming to rest in a swampy area.

Fig.1: Google Earth imagery of crash site in relation to runway 14 at MYNN

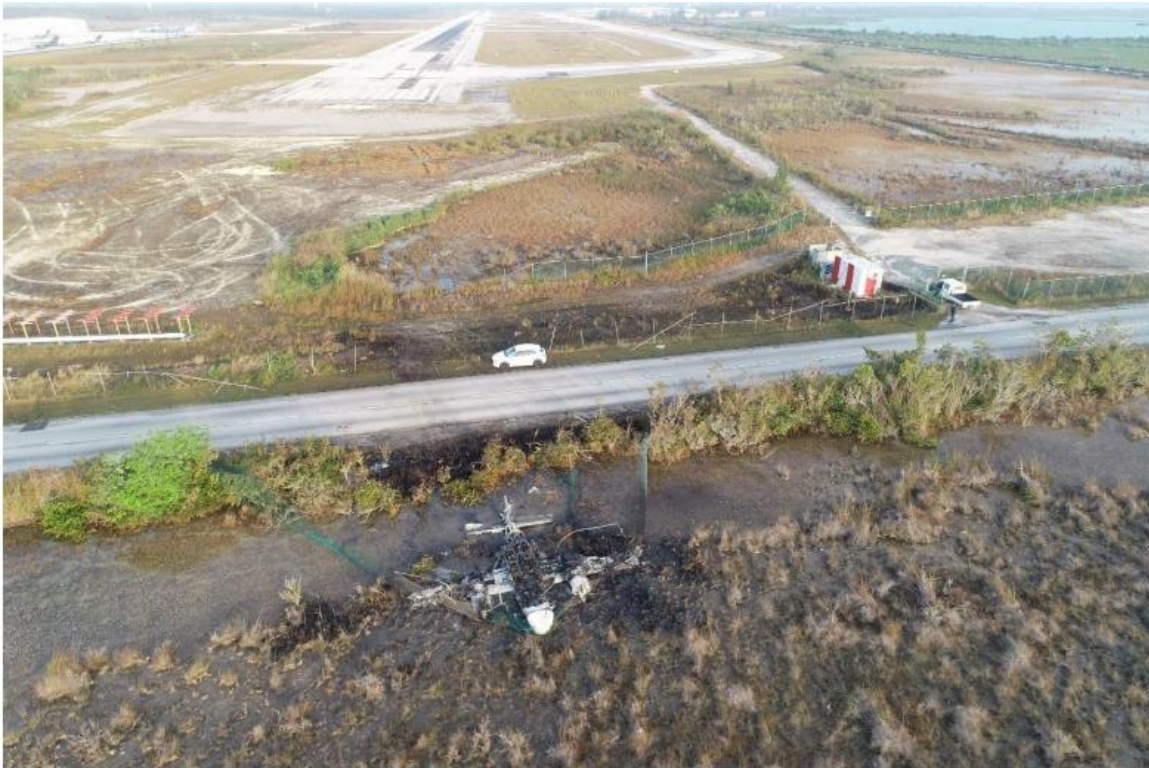
Fig.2 Drone photo of C6-JTJ from approach end of runway 32 at MYNN

The aircraft impacted the inner layer of perimeter fencing, hitting the surface and travelling for some 57 feet on a heading of approximately 123° before impacting the second outer layer of perimeter fencing. The aircraft's trajectory continued in that general direction travelling for an additional 216 feet, sliding across Coral Harbour Road before coming to rest in a swampy area.

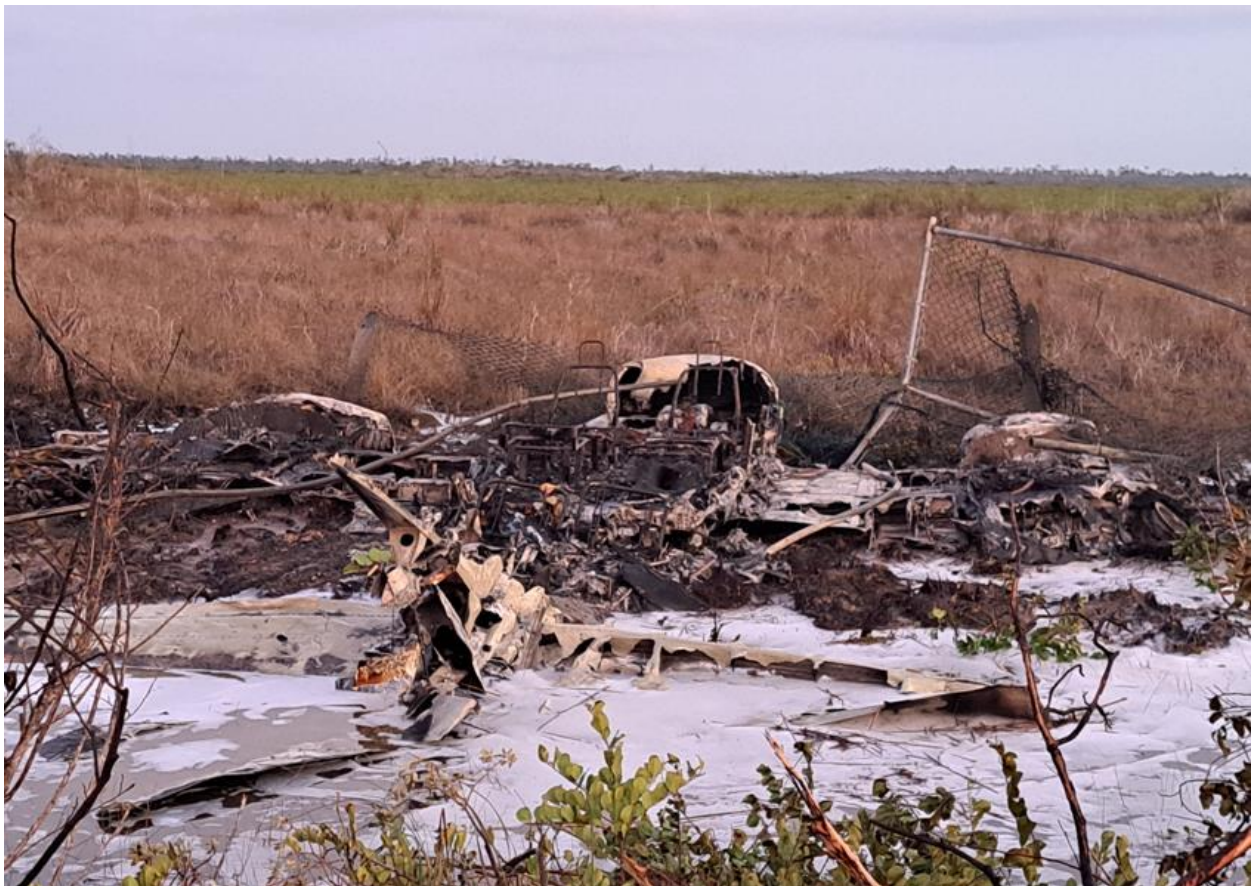
As soon as he was able to vacate the general area of the downed aircraft, the pilot observed an explosion and the aircraft continued to burn.

Fig.3: Burnt remnants of C6-JTJ
