Location	Occurrence
6.5 NM west of	Number OCC-2024/0044
Lynden Pindling Int'l	OCC-2024/0044
(MYNN), Nassau, Bahamas	
Occurrence Date & Time	Registration
12th September 2024	N555MH
2:35 pm local (1835 UTC)	
Aircraft Make/Model	Serial Number
Piper PA-23-250	27-7304938
Flight Conducted Under	Occurrence
Visual Flight Rules (VFR)	Category
	Controlled Flight
	Into Terrain (C-FIT)
Information:

### Narrative:

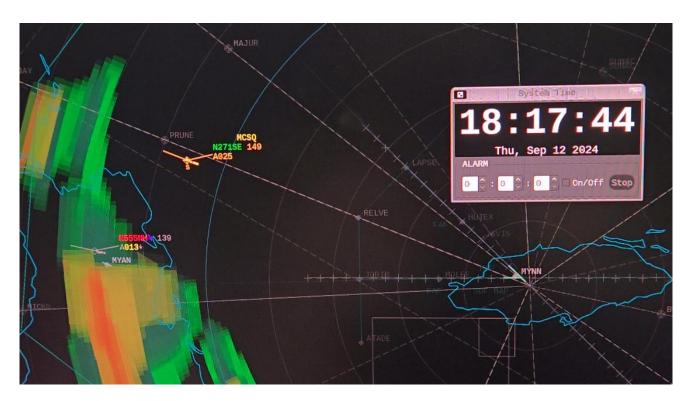
According to Nassau air traffic control radar data, at approximately 2:09 pm (1809 UTC), N555MH was shown descending from an altitude of approximately 1,700 feet while north east of the field at a distance of just over 2 nautical miles.

- @18:12:38z N555MH disappeared off radar
- @18:13:26 N555MH reappears on radar west of MYAN headed southerly direction
- @18:14:02z N555MH made hard left turn headed northeast bound passing runway (rwy) 12 descending out of 1600 ft.
- @18:16:37z N555MH made right orbit, appeared to turn to once again land rwy 12. Aircraft descended out of 1600 ft. to 1200 ft.
- @18:17:56z N555MH disappeared off radar over MYAN descending out of 1300 ft.
- @18:20:00z N555MH reappeared on radar NW of MYAN in a southeasterly direction at 1000 ft.
- @18:23:14z N555MH starts decent from 1000 ft. to 600 ft. in an easterly direction
- @ 18:24:21z N555MH advised Nassau Approach Control that he could not land at MYAN and is headed back to MYNN. Selected rwy 10 as preferred runway. Climbed to 2000ft.

Fig. 1 Nassau Approach Control Radar image of N555MH aprroach into MYAN

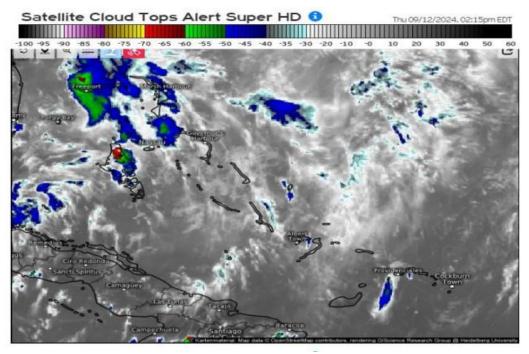
Fig.2 Sattellite imagery depicting cloud conditions for The Bahamas at 2:15 pm (1815 UTC)

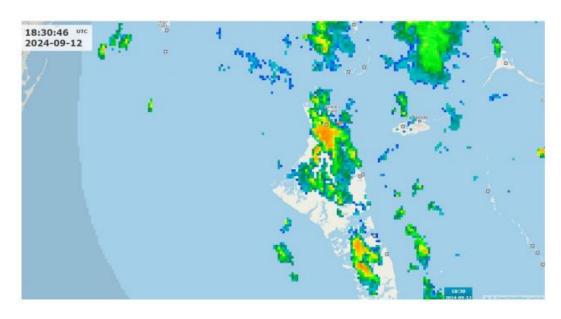
However, as he got closer, he observed a "wall of weather" at the edge of the runway and also noted that he overheard N555MH on UNICOM frequency indicating that he was returning to MYNN as he was unable to land at MYAN.

Fig.3 Radar imagery depicting conditions at MYAN at 2:30 pm (1830 UTC)

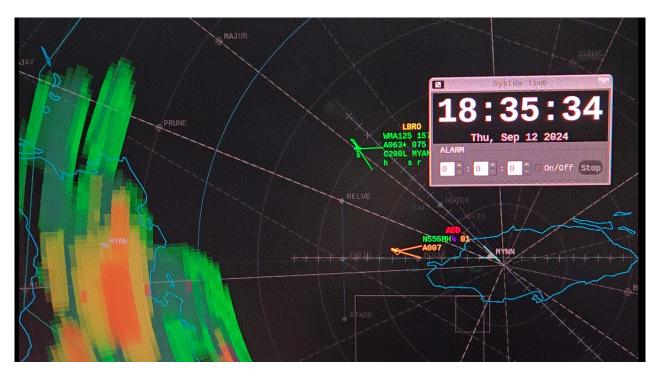
- @18:35:34z N555MH ditched into the water and disappeared one final time. WMA125 who was enroute to the crash site advised that he saw something in the water

Fig. 4 Last radar indication of N555MH before loss of radar contact (ditching)

The aircraft came to rest at coordinates 25° 2'53.74"N 77°35'45.92"W, approximately some 6.5 NM west of MYNN.
