Aviation Short Investigation Final Report

Loss of Control – Inflight (LOC-I)

Piper PA-32R-301, N9253M

**Near the Exuma Cays, Bahamas
9th June 2023**

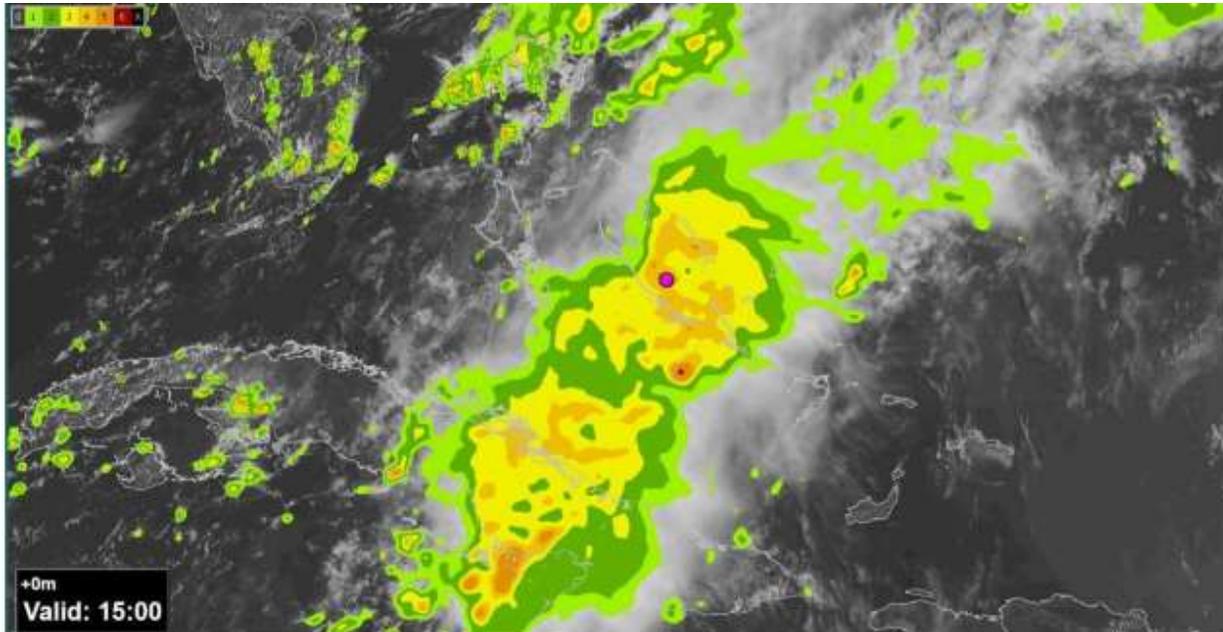
Fig.3: Merged OPC⁹ Precipitation Image at 11:00 am (NTSB Specialist Report) Purple dot last known position of N9253M

The NTSB Specialist Report concluded that the meteorological environment in the area of the last known location of N9253M was characterized by convective hazards that included instrument meteorological conditions, extreme turbulence, lightning, and icing at higher altitudes.

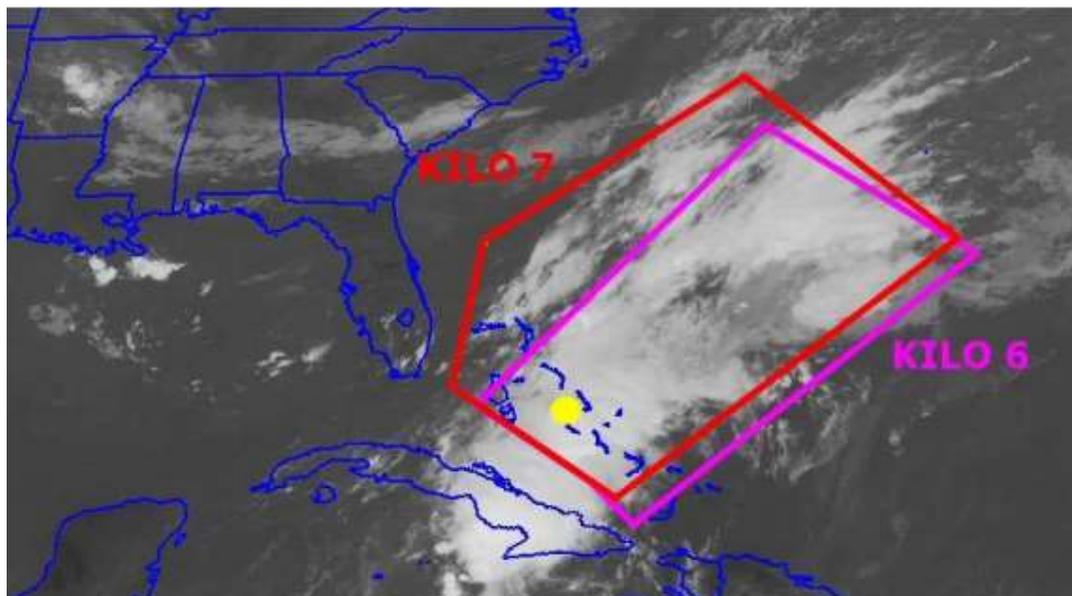
Fig.4: SIGMET Advisories (NTSB Specialist Report) Yellow dot denotes last known location of N9253M

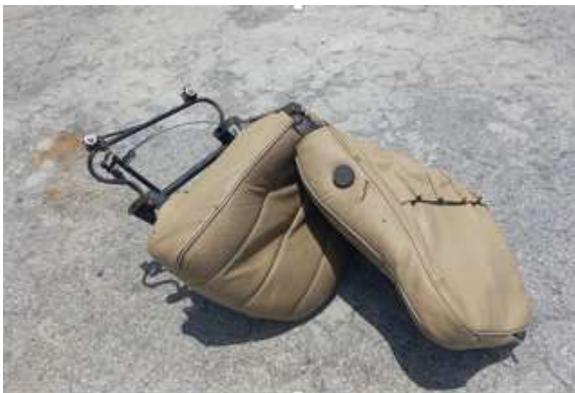
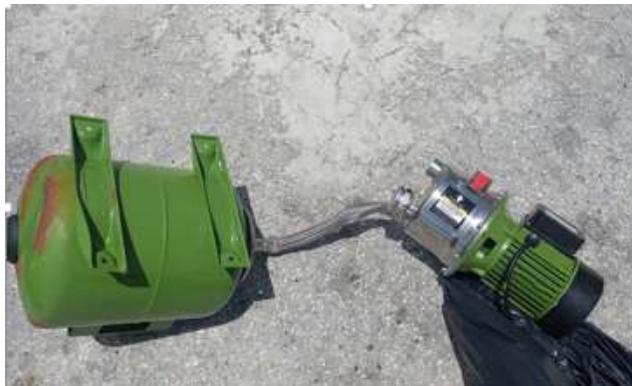
The aircraft was never located. During search and rescue, three (3) items (aircraft seat, life vest, bilge pump) were recovered, which investigations later revealed were from N9253M.

Fig. 7: Photos of aircraft seat and bilge pump found during search and rescue for N9253M

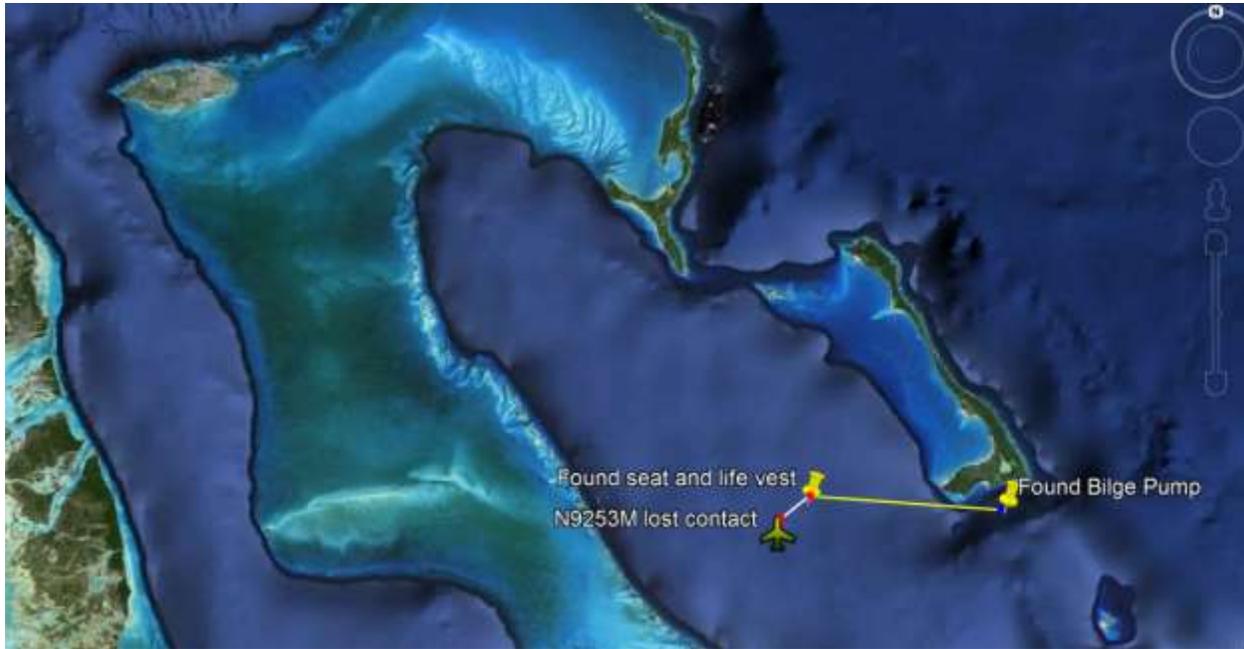
Fig.8: Location of found aircraft seat and life vest and bilge pump in relation to last known location of N9253M
