## Short Investigation Bulletin

**DATE:** November 28, 2022  
**REPORT #** OCC-2022/0034  
**AIRCRAFT REGISTRATION:** C6-CAB  
**INVESTIGATION STATUS:** Completed

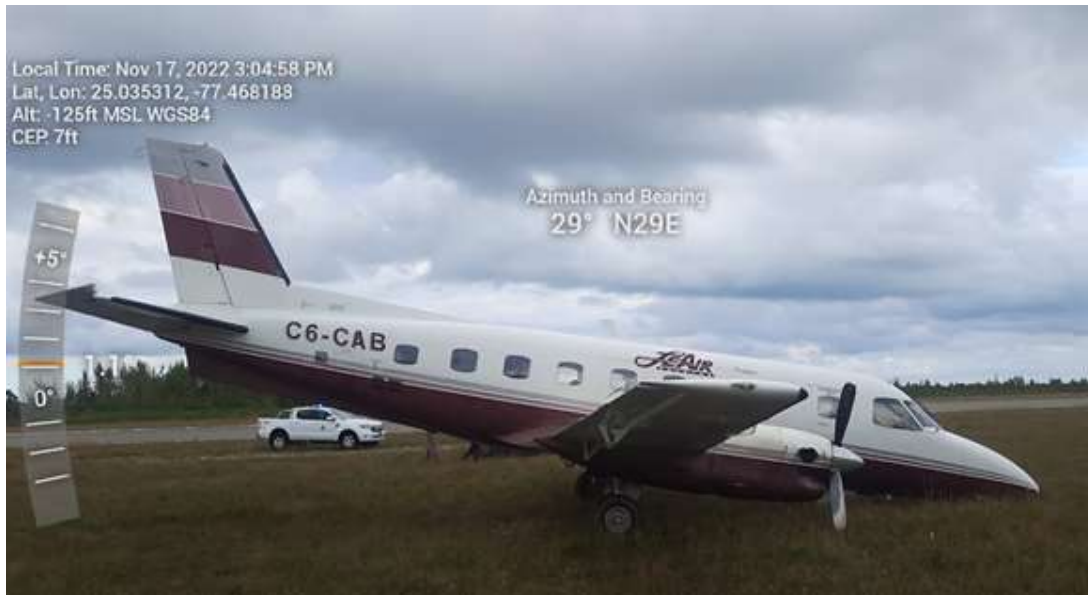
**Fig. 1 Photo of accident aircraft on side of runway 10 at MYNN**

The aircraft received damages to both propellers, nose cone, and the underside of aircraft nose. Emergency response protocols [Airport Rescue & Fire Fighting (ARFF), Royal Bahamas Police Force (RBPF)] were initiated as required and there were no reported injuries. AAIA investigators were immediately dispatched and conducted the on scene portion of its investigation into the accident.

In the aftermath of the occurrence, during follow up assessments with the operator, it was discovered that the nose gear steering linkage was broken. This mechanical failure was identified as contributory to the prevention of the extension of the nose landing gear.

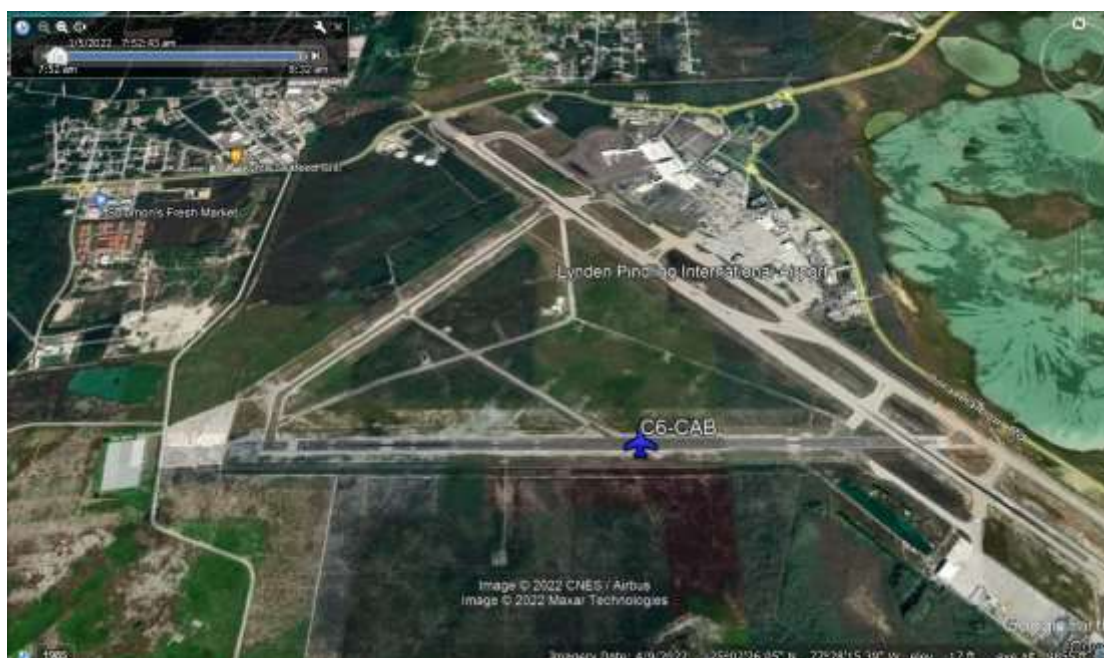
After the nose of the aircraft came into contact with the runway surface, the aircraft veered to the right side of runway 10 and eventually exited the paved runway surface at a distance of approximately 3,280 feet from threshold of runway 10. It then travelled for approximately 804 feet from the exit point before coming to rest and oriented in a north-easterly direction, approximately 40°.

**Fig. 2 Google earth image of accident aircraft point of rest**
