# Aviation Short Investigation Final Report

Cessna 402B, C6-SPK

**Near Eleuthera, Bahamas  
19<sup>th</sup> August 2023**

**Report Number #OCC – 2023/0029**

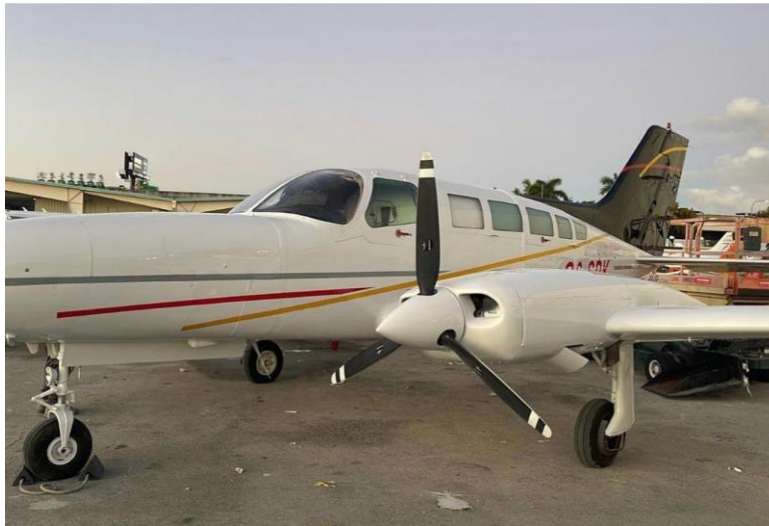
During the course of this investigation, there was no evidence or documentation obtained pertaining to the maintenance of the aircraft to indicate that it was maintained in accordance with the manufacturer's specifications.

*Fig. 1: Photo of aircraft (US Coast Guard)*

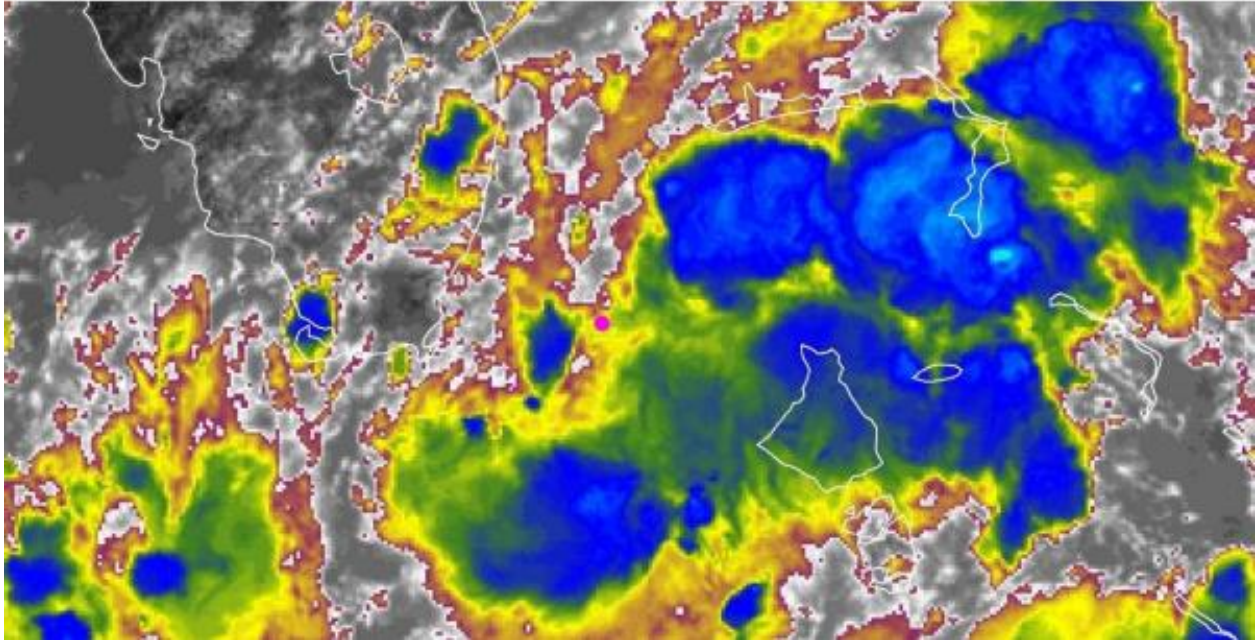
*Fig 2: Infrared Imagery from 1658 UTC (NTSB Specialist's Factual Report)*

The imagery depicts cloudy conditions over the accident region with features consistent with deep convection.

Textual and graphical weather data and information presented in both reports revealed that the meteorological environment within the accident region contained convective hazards that might have included instrument meteorological conditions (IMC), extreme turbulence and icing at higher altitudes.

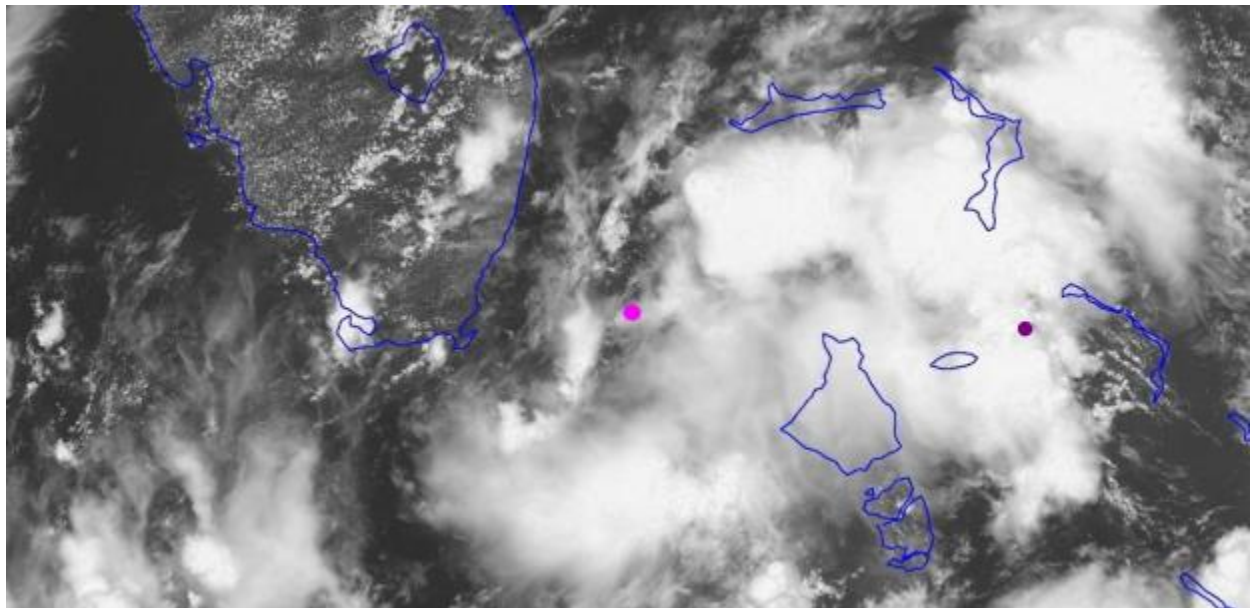
*Fig.3: Satellite Imagery from 1658 UTC (NTSB Specialist's Factual Report) purple dots are approximate initial and updated aircraft positions*

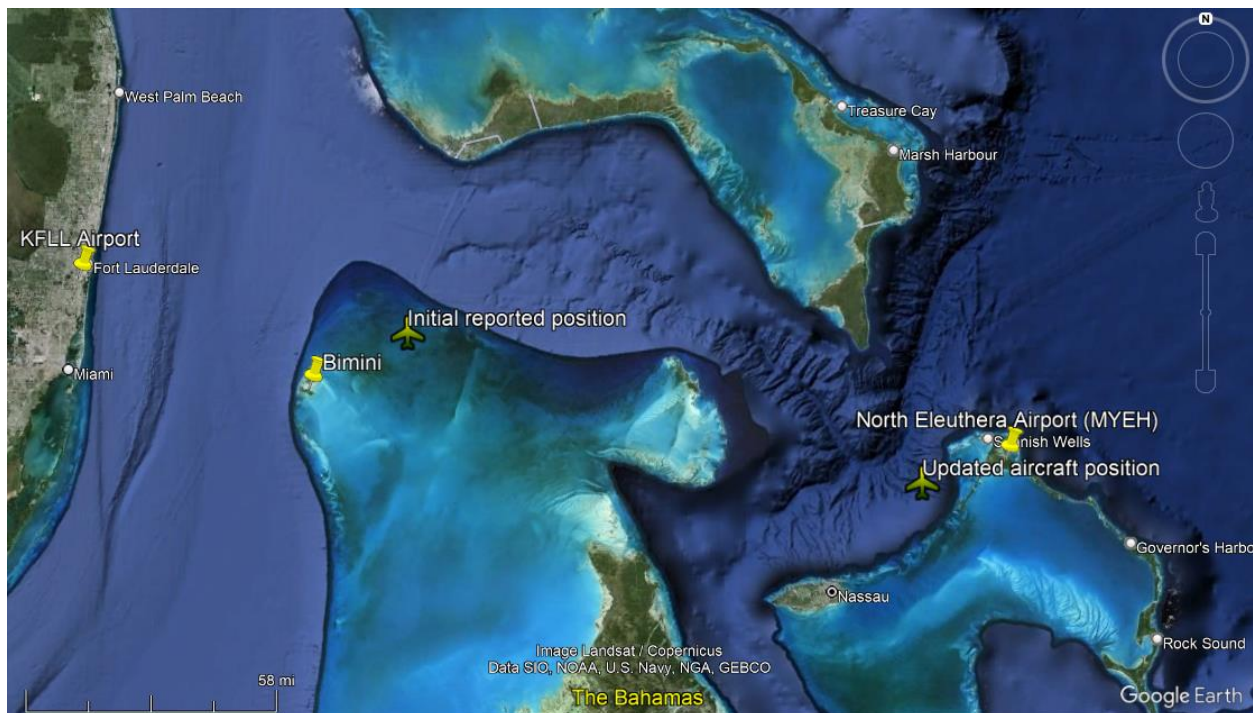
The aircraft was observed in a rapid descent by air traffic control from an altitude of approximately 8,400 ft. mean sea level (MSL) to about 4,500 ft. MSL, while at coordinates 25.84N 78.90W, approximately some 70 nautical miles south east of KFLL, or approximately 18 nautical miles north east of Bimini, Bahamas.

This position was initially identified as the last position of the aircraft, however, an updated aircraft position at coordinates 25°20'35.00"N 76°59'46.00"W, a distance of approximately 17 nautical miles southwest of North Eleuthera International Airport (MYEH) was later revealed via the United States Coast Guard based on further analysis conducted.

*Fig.4: Initial and updated position of aircraft*

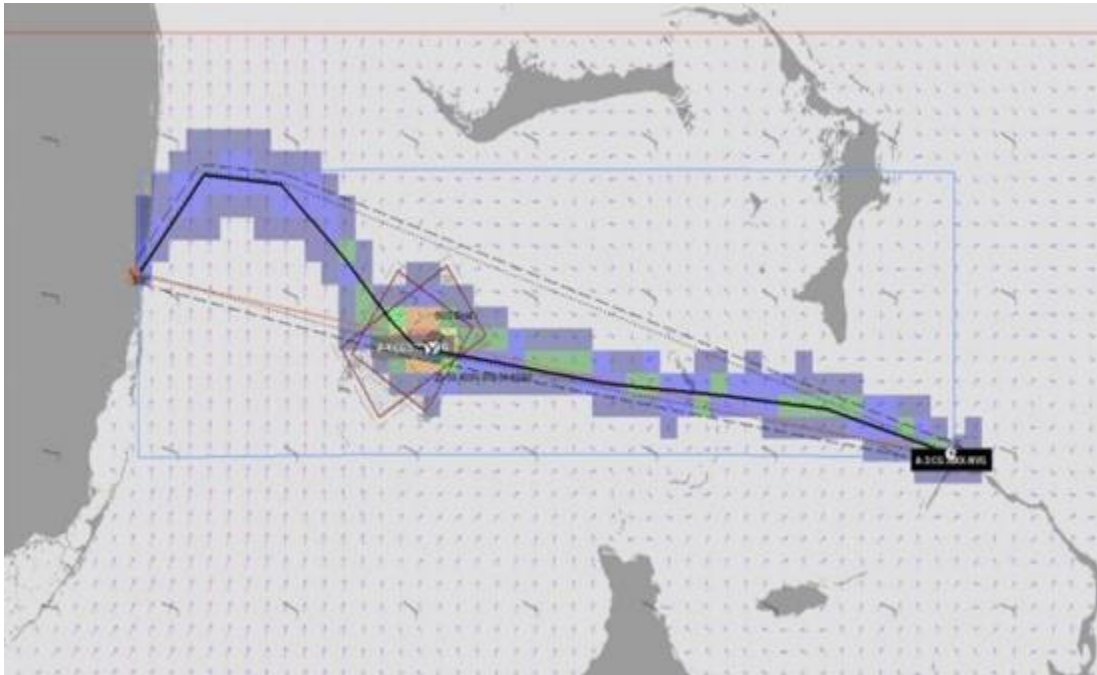
US Coast Guard aircraft designated “144” conducted initial search within the areas identified between 8:21 pm until after 1:00 am on 20<sup>th</sup> August 2023. Their search yielded negative results.

*Fig. 5: Flight track of US Coast Guard aircraft 144*
