AIRCRAFT ACCIDENT REPORT

CATASTROPHIC ENGINE FAILURE

CESSNA T210H

N2219R

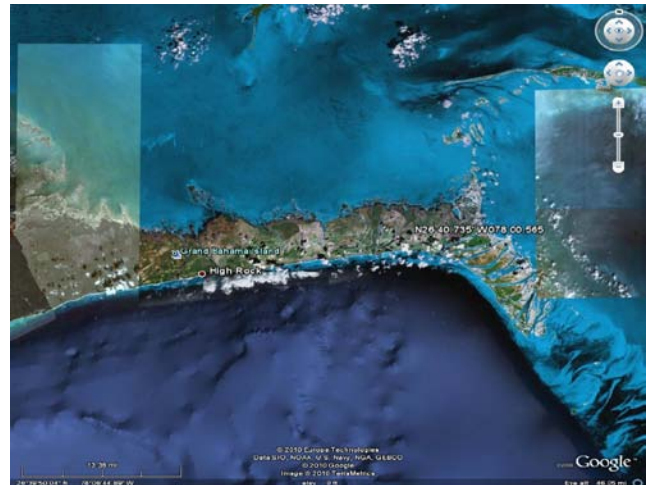
reported as Visual Meteorological Conditions (VMC). The aircraft hit several trees prior to contact with the ground. It caught fire and exploded several seconds later. It was destroyed by post impact fire. The wreckage is located at coordinates N26° 40’735” and W 078°00’565”. The aircraft came to rest on a Magnetic heading of 265°.

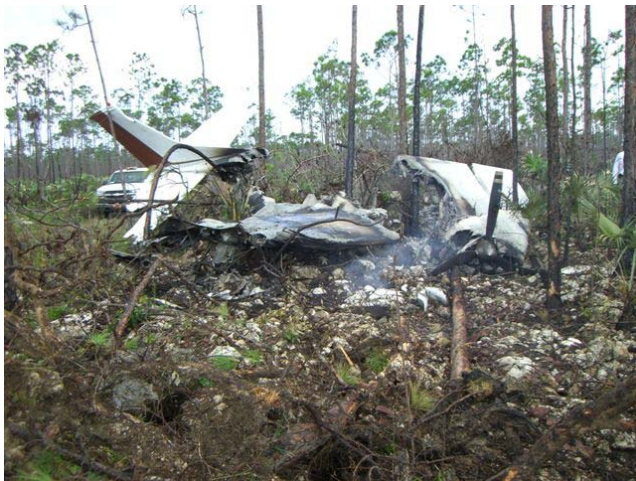
The aircraft hit several trees while attempting to land on the service road. The pilot exited the aircraft and it exploded several seconds later and was burnt extensively.

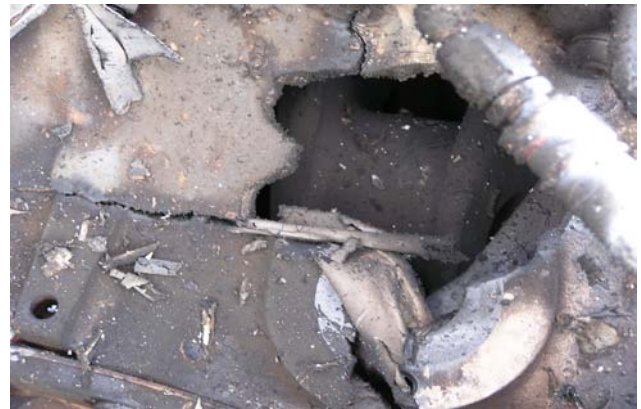
Approximately 80% of the aircraft was completely destroyed by the crash and post impact fire. The empennage was the only part not destroyed by the crash and post impact fire. Below photo shows the exit point of engine parts which contributed to the catastrophic engine failure.

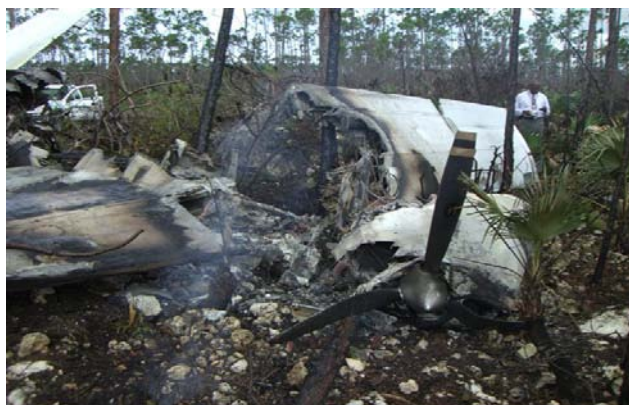
The aircraft came to rest on a Magnetic heading of approximately 265 degrees. The wreckage was located at coordinates N26° 40'735' and W 078° 00'565''.

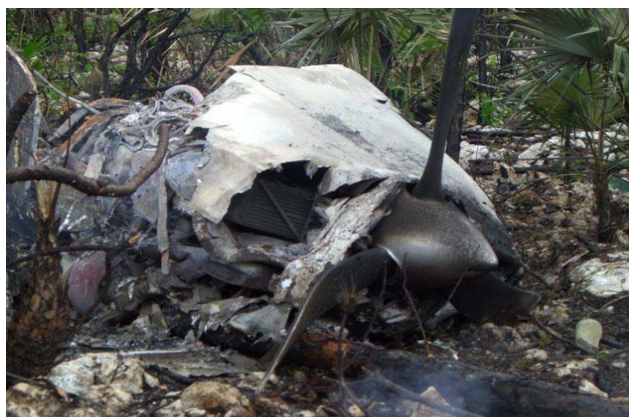
The aircraft hit several tall pine trees prior to making contact with the ground. It caught fire and exploded several seconds later. The aircraft was almost completely destroyed in the post impact fire.

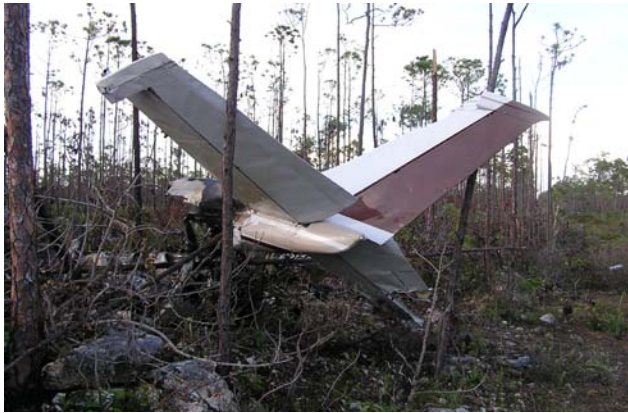
A fire erupted after the aircraft made impact with the ground. The post impact fire completely engulfed and destroyed the aircraft except the empennage (tail section - elevator, rudder, horizontal and vertical stabilizer). The immediate area containing brush and other small shrubbery was also destroyed by the post impact fire.
