AVIATION OCCURRENCE BULLETIN

DATE: 20TH AUGUST, 2019
REPORT # AO-19-000045
AIRCRAFT REGISTRATION: N66GF
INVESTIGATION STATUS: COMPLETED

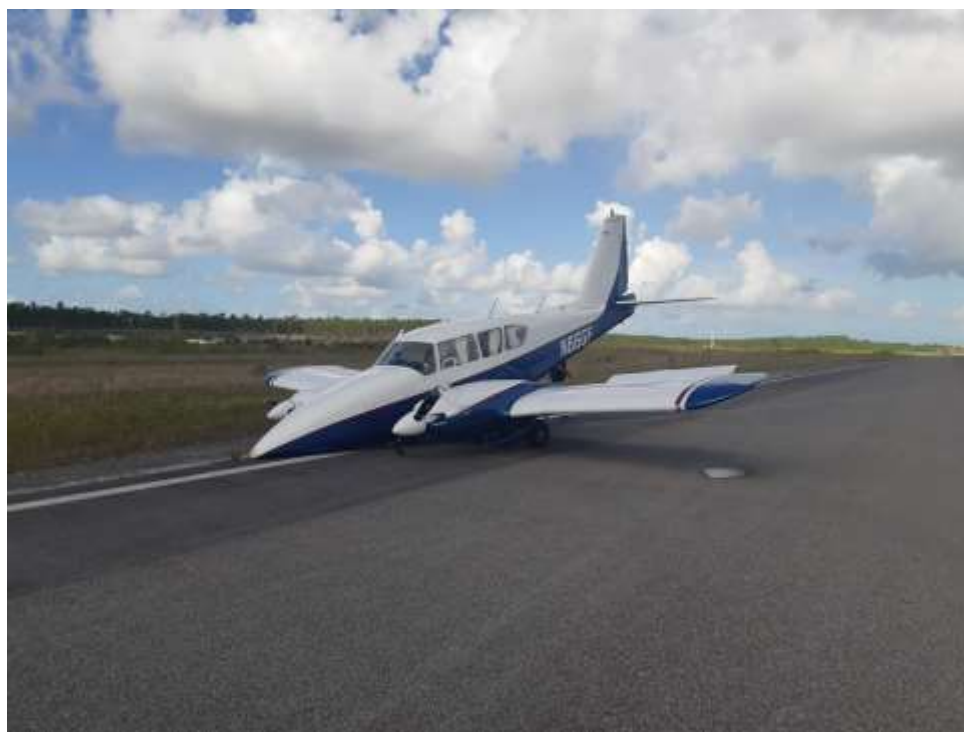
Prior to landing runway 09 at MYAM, the pilot made verification of all gears down and locked with indication of green lights. Upon initial contact with the runway, the nose gear collapsed and subsequently exited to the right of the runway.

The aircraft received damages to both propellers, nose cone, and undercarriage. There were no injuries reported in relation to this accident.
