AVIATION OCCURRENCE BULLETIN

DATE: 28 JUNE, 2019 REPORT # AO-18-000016 AIRCRAFT REGISTRATION: N8355H INVESTIGATION STATUS: COMPLETED

Date and Time of Occurrence:	July 31, 2018, 4:02pm Local			
Location	Lynden Pindling Int'l Airport Runway 09			
Persons on Board	Crew	1	Passengers	1
Injuries:	Crew	None	Passengers	None
Commanders License:	Private Pilot			
Occurrence category:	Runway Excursion due to gear not extending			
Occurrence type:	Serious Incident			
Investigation status:	Final Report Complete

Aircraft details			
Aircraft Type and Registration:	Piper PA32R-301, N8355H		
Year of Manufacture & Serial #:	1981, 32R-8113052		
Number and Type of Engine(s)	1Lycoming IO-540-SER		
Type of operation:	Private, General Aviation		
Information Source:	AAID Field Investigation		
Nature of Damage:	Extensive

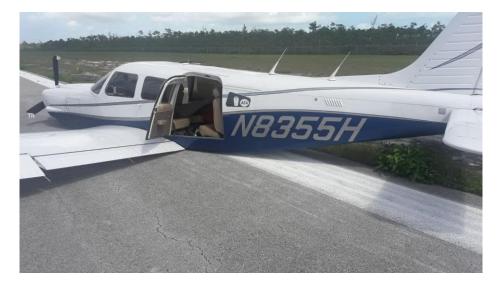
On 26 July, 2018 at approximately 4:00pm local, a Piper PA32 aircraft registration N8355H was involved in a runway excursion upon landing at the Lynden Pindling Int'l Airport. Two souls on board did not receive any injuries as a result of the excursion.

The pilot stated that his battery was dying and so he advised ATC ahead of time of the battery issue. The battery eventually died resulting in the gears not being able to extend despite emergency and normal procedures to extend them. The pilot decided to land the aircraft without the gears which resulted in the aircraft runway excursion.
