N351BL Preliminary Occurrence Report

Release Date 26th August 2024

Location Near the Leonard Thompson Int'l Airport (MYAM), Marsh Harbour, Abaco, Bahamas	Occurrence Number OCC-2024/0037
Occurrence Date 4 th August 2024 12:05 pm (1605 UTC)	Registration N351BL
Aircraft Make/Model BRM Aero SRO Bristell S-LSA	Serial Number 033/2013
Flight Conducted Under Visual Flight Rules	Occurrence Category Undetermined

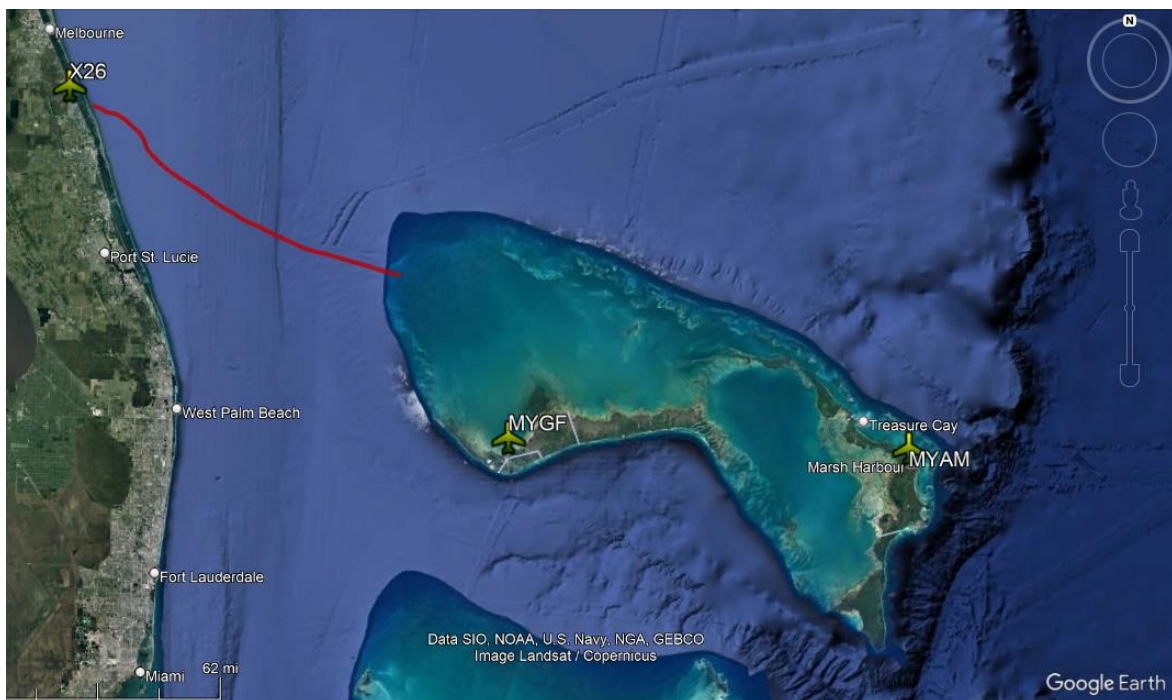
Fig.1: Aircraft route of flight prior to approach into MYAM

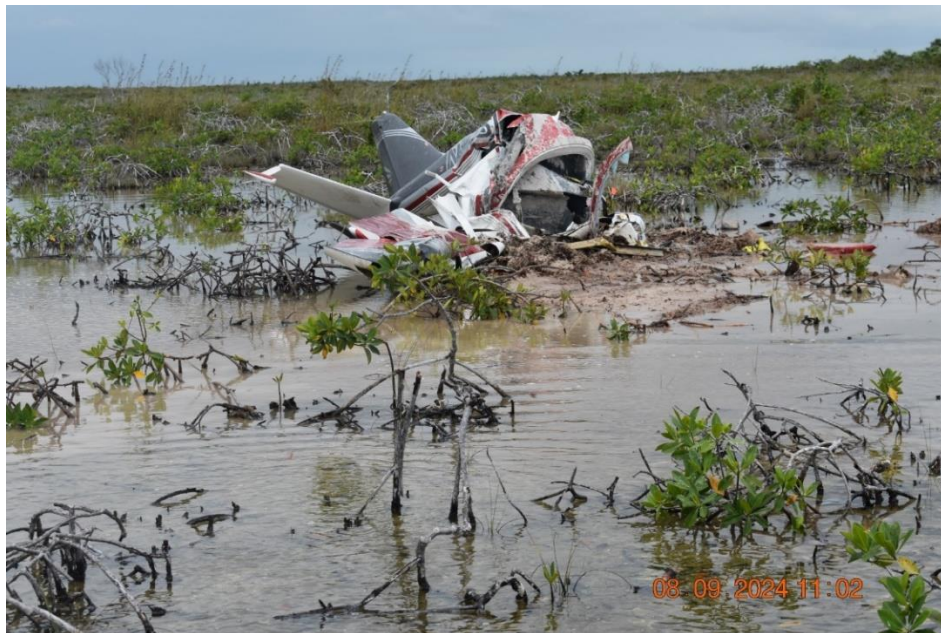
Fig.2: Wreckage of N351BL

The aircraft was observed to have sustained heavy impact damage.

The forward section of the aircraft was embedded into the marsh. Both wings were attached to the aircraft with the leading and trailing edges sustaining substantial damage. The right wing flap appeared to be in an extended position. Upon inspection of cockpit instrumentation, it was observed that the flap indicator was positioned to 30° (full extension).

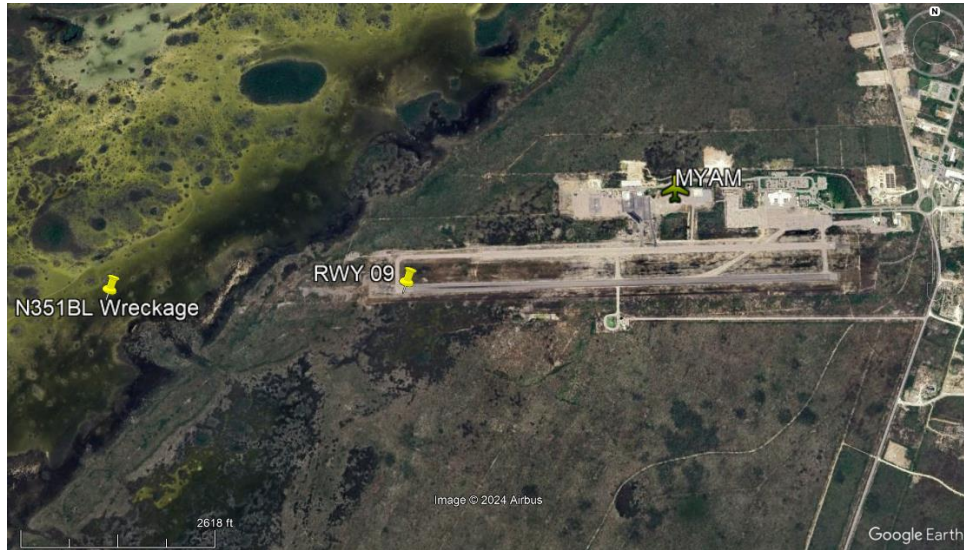
On the 8th of August 2024, shortly after noon, the AAIA was notified that the presumed wreckage of N351BL was located by pilots assisting in search efforts. It was later confirmed to be the aircraft, which was found in an area of marsh land at coordinates 26°30'34.00"N 77° 6'26.00"W at a distance of approximately 0.6 nautical miles or approximately 4,000 feet west of the approach end of runway 09 at MYAM.

The aircraft was oriented facing a heading of approximately 86°. The debris field extended along a path consistent with an easterly heading in alignment with runway 09 at MYAM, with pieces of debris scattered on both sides of the 86° orientation of the aircraft.

Fig.3: N351BL Crash site in relation to runway 09 at MYAM

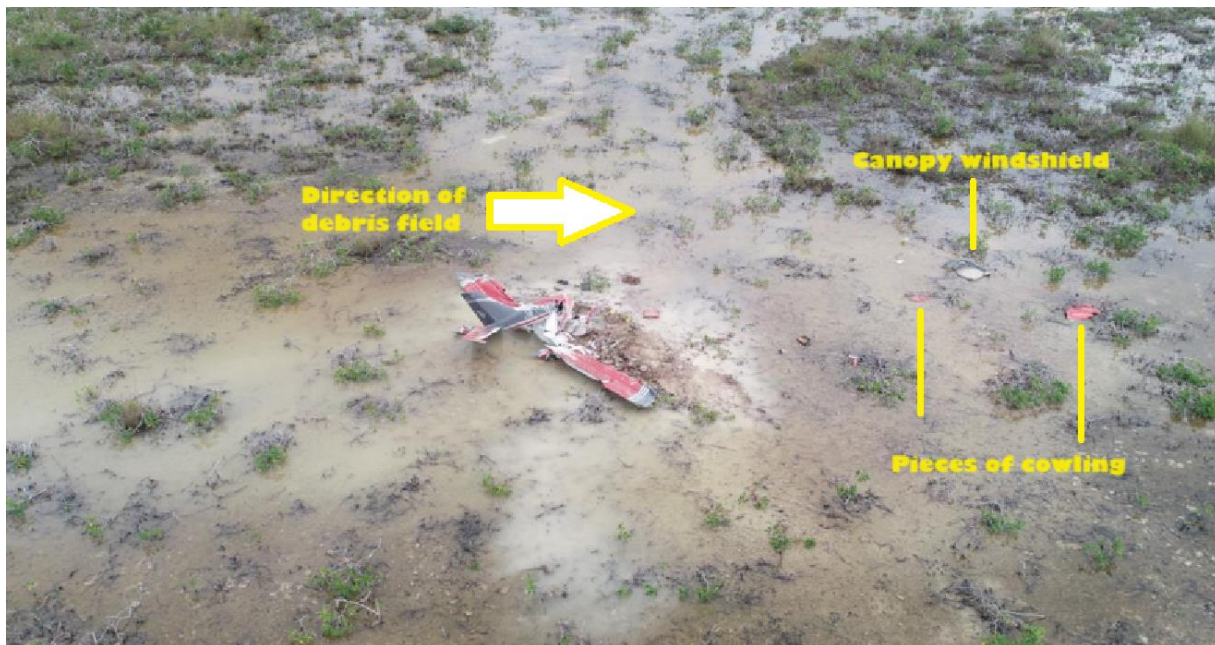
The debris field, measured from the crumpled fuselage, extended forward for a distance of approximately 72 feet to the furthest piece of debris (section of cowling).

Fig.4: Drone view of debris field at crash site
