Aviation Short Investigation Final Report

Loss of Control – Inflight (LOC-I)

Piper PA-32R-301, N9253M

**Near the Exuma Cays, Bahamas
9th June 2023**

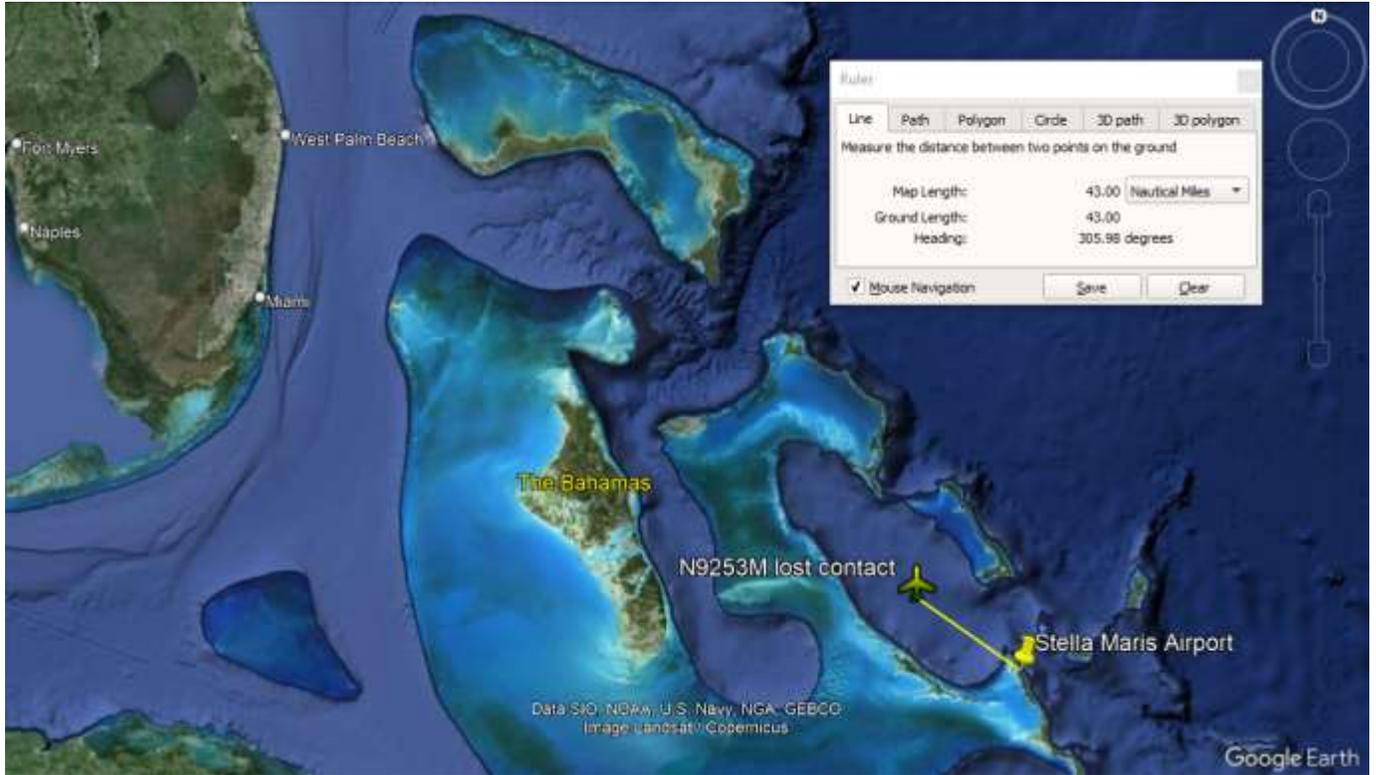
Fig.6: Last known position of N9253M in relation to destination Stella Maris Airport (MYLS)

The last known location of the aircraft was identified at coordinates 23 59 39.6N 075 55 11.7W, the point at which N9253M lost radar contact with Miami Center at an approximate distance of some 43 nautical miles from Stella Maris Airport (MYLS).
