AIRCRAFT ACCIDENT REPORT

CATASTROPHIC ENGINE FAILURE

CESSNA T210H

N2219R

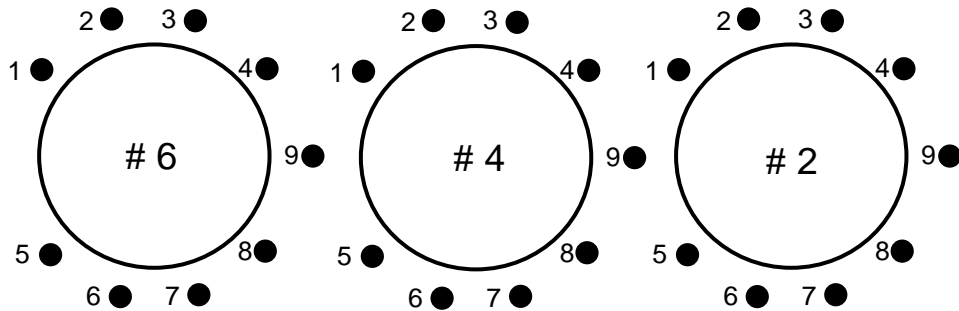
Cylinder Through-Bolt and Deck Stud Break-Away (Tightening / Loosening) Torque Measurements – Inch Pounds
(Position numbers 1 and 5 are through-bolts)

Bolt 1	Stud 2	Stud 3	Stud 4	Bolt 5	Stud 6	Stud 7	Stud 8	Stud 9
	Tight / Loose	Tight / Loose	Tight / Loose	Tight / Loose	Tight / Loose	Tight / Loose	Tight / Loose	Tight / Loose	Tight / Loose
Cylinder #2	/	/	/	/	/	/	/	/	/
Cylinder #4	/	/	/	/	/	/	/	/	/
Cylinder #6	/	/	/	/	/	/	/	/	/

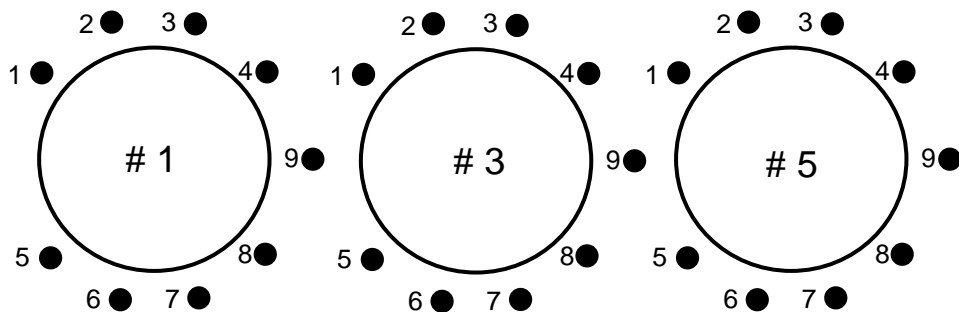
Bolt 1	Stud 2	Stud 3	Stud 4	Bolt 5	Stud 6	Stud 7	Stud 8	Stud 9
	Tight / Loose	Tight / Loose	Tight / Loose	Tight / Loose	Tight / Loose	Tight / Loose	Tight / Loose	Tight / Loose	Tight / Loose
Cylinder # 1	/	/	/	/	/	/	/	/	/
Cylinder # 3	/	/	/	/	/	/	/	/	/
Cylinder # 5	/	/	/	/	/	/	/	/	/
