Location	Accident number
West End Airport	OCC-2024/0023
(MYGW), Grand	
Bahama, Bahamas	
Occurrence Date &	Registration
Time	N60SU
12 th April 2024,	
10:40 AM local	
(1440 UTC)	
Aircraft	Serial Number
Piper PA-28R-201	2844121
Fipel FA-20K-201	2044121
Flight Conducted	
Under	
Visual Flight Rules	
Information:

Narrative:

On 12th April, 2024 at approximately 10:40 am local (1440 UTC), a Piper PA-28R-201 with United States Registration N60SU was involved in an occurrence while landing at the West End Airport (MYGW), West End, Grand Bahama, Bahamas.

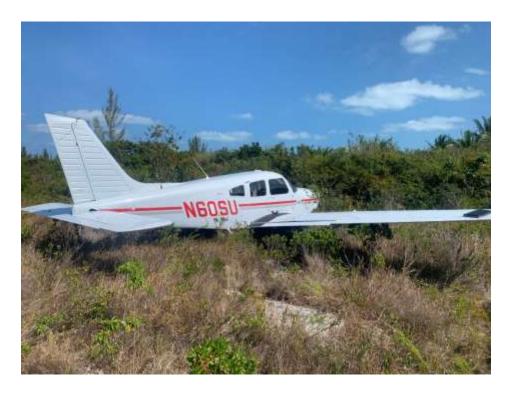
were made with brakes and rudder, again the pilot reported that the aircraft did not respond and it continued on its trajectory which led to a runway excursion taking place to the right of runway 30 and coming to rest in bushes on the side of the runway.

The aircraft received damages to its wings. There were no injuries reported in relation to the occurrence.

Fig. 1: Photo of N60SU after landing at MYGW
